Product Quality Update

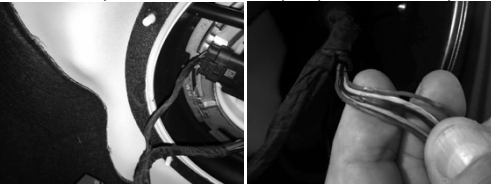
4. FC194501/194601 short to B+

- Wiring harness issue
- Follow diagnosis of NVLD harness
- SI B16 04 17 in preparation

Product Quality Update
Harness pinched between fuel pump cover and body
