- E9x (3 Series) and E82/E88 (1 Series) from 09/08 with option 609
 - Road Map 2009-1 for the Car Information Computer (CIC) navigation system
- NAV road map set shipped to all BMW Centers through the Automatic Tool Shipment Program

- E83 (X3), E60 (5 Series) up to 11/05
 - Recall for OC3 mat (update)

- E70 (X5), E71 (X6) produced up to 8/08 and equipped with Comfort Seats
 - Thigh support cover loose

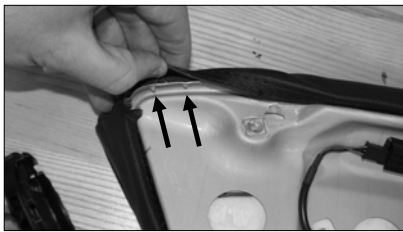
- Insufficient fastening of the cover to the retainers

1. Remove the thigh support from the seat
2. Pull back the loose material
3. Bend the retaining tabs inward to achieve a 3-4mm gap

4. Secure the cover by pressing it down into place
 5. If it will not lock into place and the plastic retaining flange is damaged, the cover needs to be replaced
- SI B52 02 09

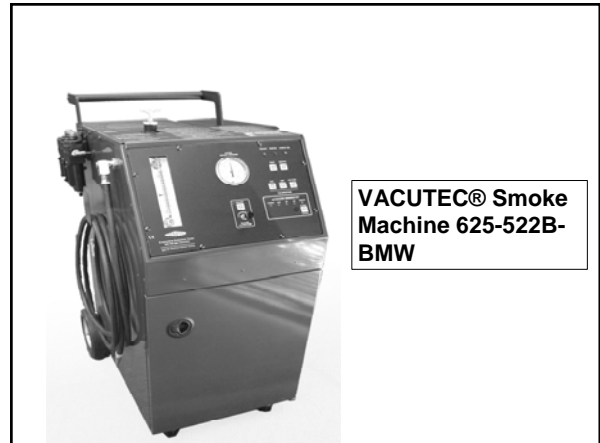
- E70 (X5), E90 (3 Series) with M57Y Diesel
 - Service Engine Soon illuminated
 - "Reduce Engine Power" displayed
 - FC 4521, Charge-air pressure too high, or
 - FC 4530, Charge-air pressure, too low

- Possible
 - Charged air leakage in the intake manifold
 - Air filter/air path clogged
 - Incorrect operation of wastegates or bypass valve
 - Intake pressure sensor malfunction

- Check for intake leaks using appropriate smoke machine (preferably VACUTECH® Smoke Machine 625-522B-BMW)
- With non-BMW approved smoke machines do not exceed 0.04 bar pressure (13" H₂O)
- SI B12 10 09

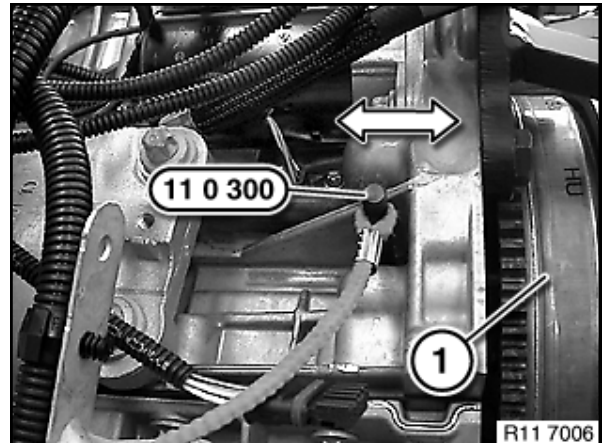
- All models equipped with N52, N52K and N54 engines
- Difficulty Installing TDC Alignment Pin Special Tool 11 0 300

- Special Tool 11 0 300 is difficult to install as described in repair instructions when checking or adjusting engine mechanical timing.

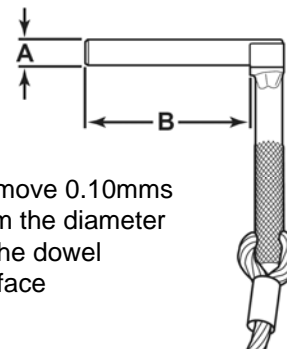
GRUSB1109-11

- Tool may bind in the bore of an N52 or N52K crankcase
- Do not modify the engine crankcase

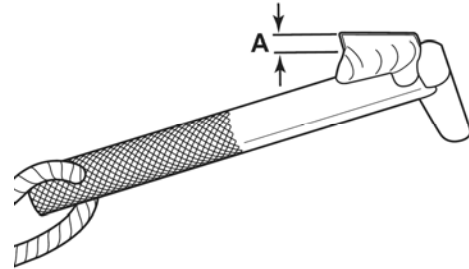
GRUSB1109-12

- N54 engine
 - Handle may interfere with the low pressure fuel supply line support

Remove 2-3 mms of material.
