BEV - Reasons For No/Slow DC Charging Complaint

The purpose of this Service Bulletin (SIB) is informational regarding DC charging complaints on Gen 5 Battery Electric Vehicles (BEV). It serves as a supporting argument and is intended to help distinguish between a standard designed function or component operation from an actual system fault in a DC charging customer complaint (i.e., “DC Not charging or “DC charging too slow”.

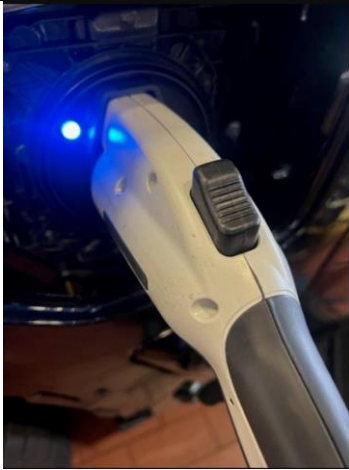
HV charging plug blue LED indicating charging

The charging indicator LED display at the HV charging plug should not be used as a diagnostic tool in service. This is designed as a quick indicator of charging state to the user (customer).

- perform ISTA diagnosis,
- check fault codes,
- run the charging history test plan to verify the customer concerns and
- then the fault relevant charging test plans to verify why the car is not charging.

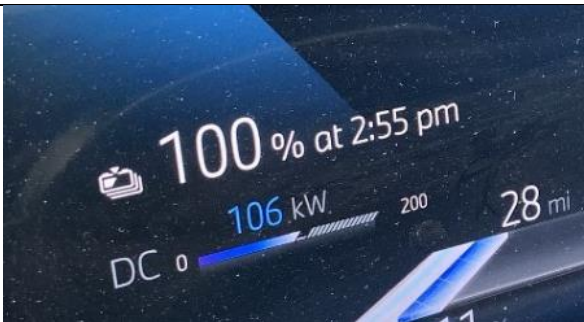
Instrument cluster charging indicator display (DC charger limitation)

If a shaded area (//////) is displayed to the right of the charging bar in the instrument cluster charge indicator during the charging process, this indicates a restriction imposed by the charger or the infrastructure the charger is connected to. In this example, the vehicle is charging at a rate of 106 kW out of a possible 200 kW.

In the second example only 48 kW are being charged. Notice the shaded area (//////) displayed is larger.

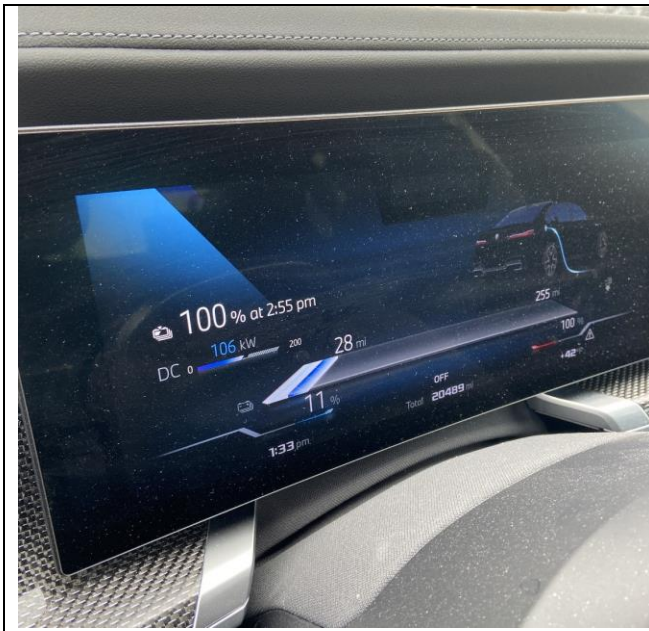
Instrument cluster charging rate indicator display

The blue shaded area displayed on the left of the charging bar, in the instrument cluster charge indicator during charging, indicates the charging rate “currently allowed” by the vehicle at this moment.

This value will be displayed in Kilowatts (kW) directly above the charge bar and will vary:

- depending on the charger used,
- the charge settings in the vehicle and
- will display a lower rate at the beginning and near the end of the charging session, especially due to battery temperature.

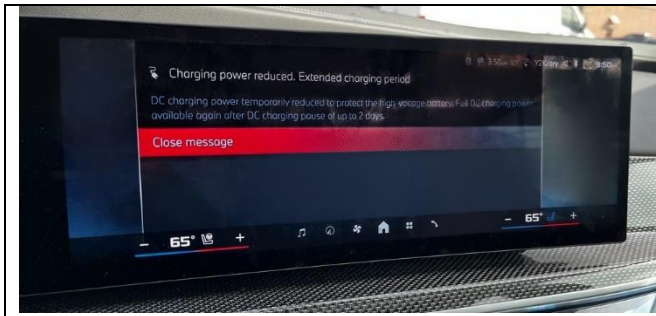
Charging power temporarily reduced Check Control Message

Charging power reduced. Extended charging time.

DC charging power temporarily reduced to conserve the high-voltage battery. Full DC charging power available again after DC charging pause of up to 2 days.

In this case to restore the frequent DC charging limitation, it is recommended to drive the vehicle normally to deplete the state of charge further than usual (for example to 40% SOC) and perform the next charging session with an AC charger (if possible).

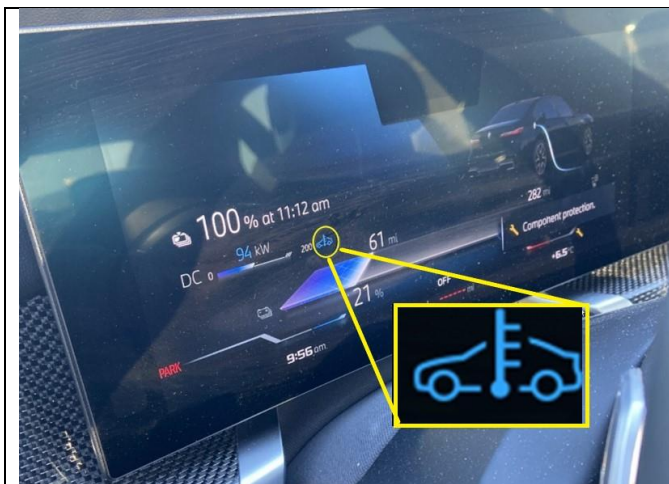
From July 2022 vehicle production onwards, when the outside temperature is below 15 °C / 59 °F, a blue car with temperature symbol appears in the instrument cluster during charging to indicate to the driver a temperature related charging limitation has been enabled.

Instrument cluster charging indicator display (temperature limitation)

It is a good practice to set preconditioning of the HV battery before charging in extreme (high or low) temperatures to avoid slow charging or having to wait at the charger while the battery ready's itself to charge.
