Engine Oil Leak Diagnosis and Repair Procedure

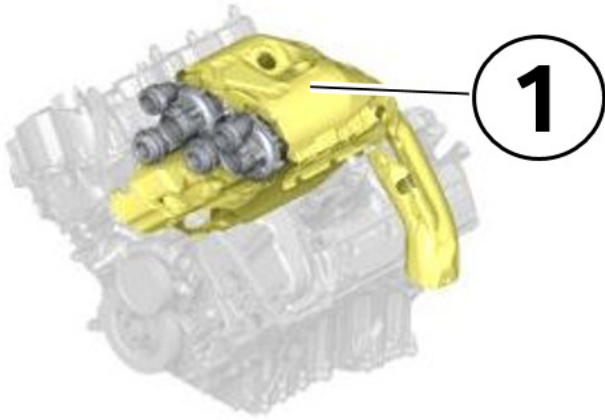
1. Remove the heat shield (1) to diagnose the engine oil leak.

Refer to Repair Instruction 11 65 180
Removing and installing/replacing heat shield at top.

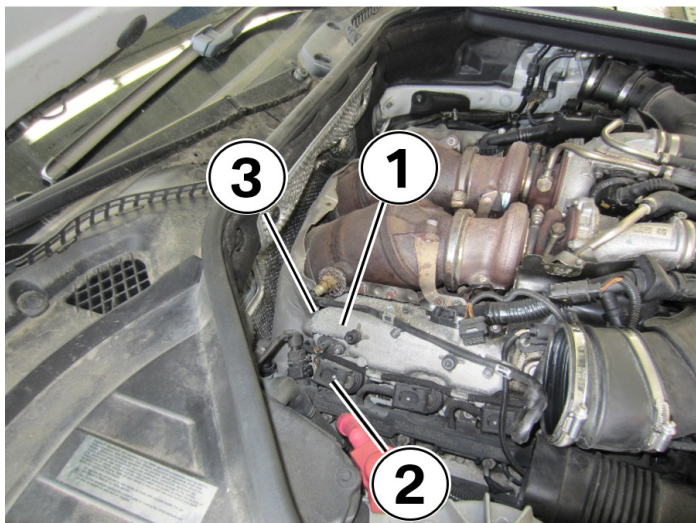
2. The illustration shows an overview of the components found on cylinder bank 1.

Cylinder head cover (1)

Cylinder # 4 (2)

Inspection location (3)

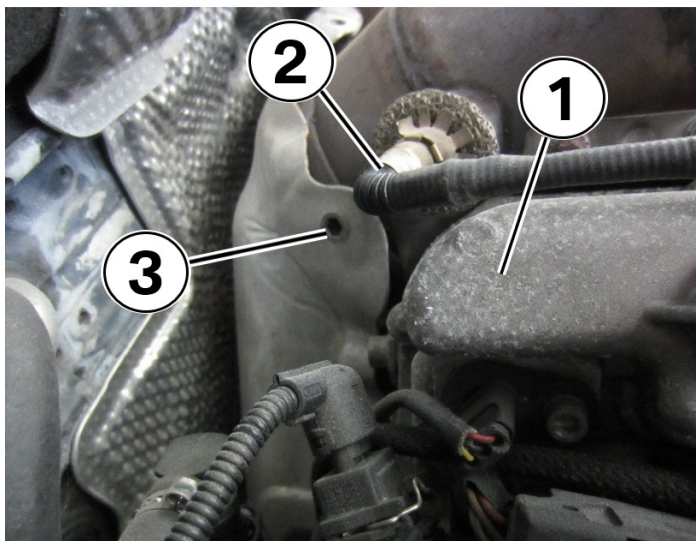
3. The illustration shows an overview of the components found on cylinder bank 1.

Cylinder head cover (1)

Bank 1 post O2 sensor (2)

Heat shield mounting hole (3)

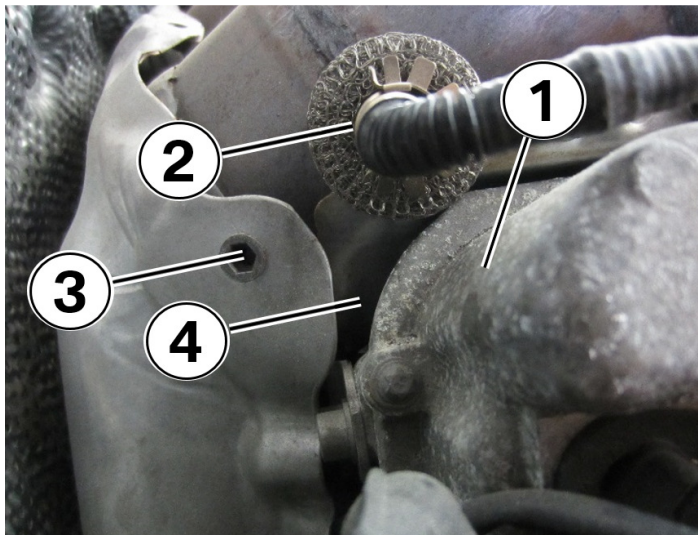
5. The illustration shows an overview of the components found on cylinder bank 1.

Cylinder head cover (1)

Bank 1 post O2 sensor (2)

Heat shield mounting hole (3)

Insert bore scope here (4) on an angle downward.

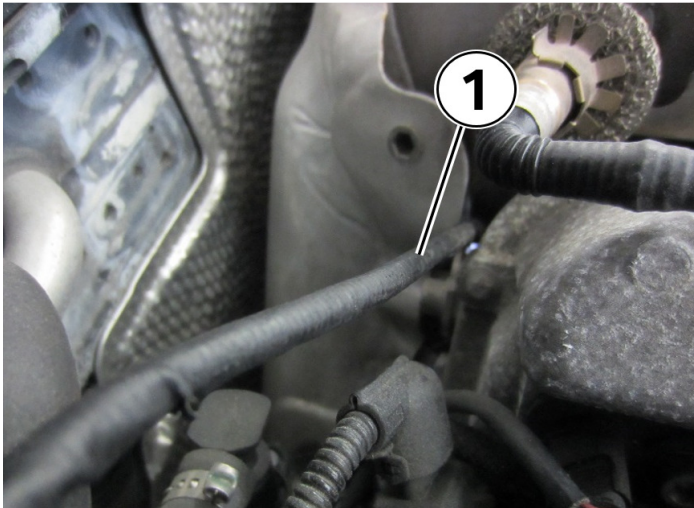
6. Approach angle of the bore scope (1) is approximately 45 degrees.

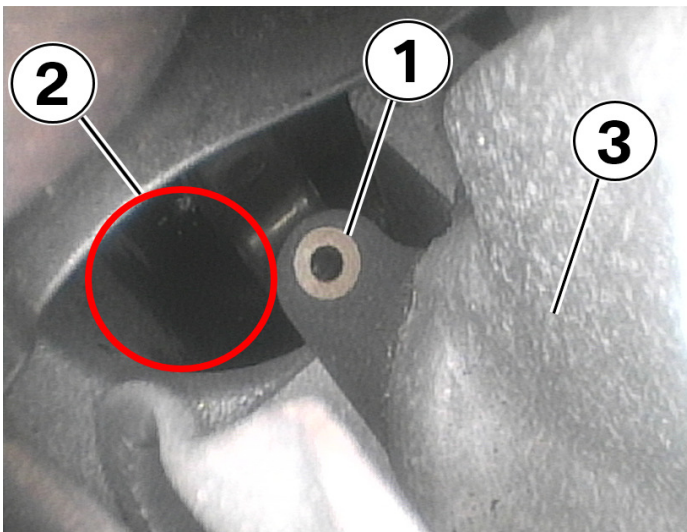
7. After inserting the bore scope you must locate the cylinder head gasket tab. (1).

The tab is approximately 135 mm straight down from original entry point.

Cylinder head gasket tab (1)

Gap in heat shields (2)

Cylinder head (3)

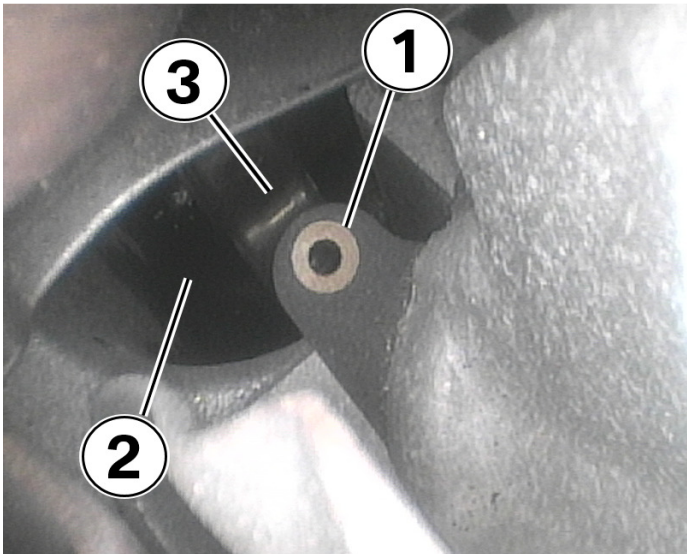
8. Feed the bore scope past the left side (1) of the cylinder head gasket tab (2) towards the vacuum reservoir (3).

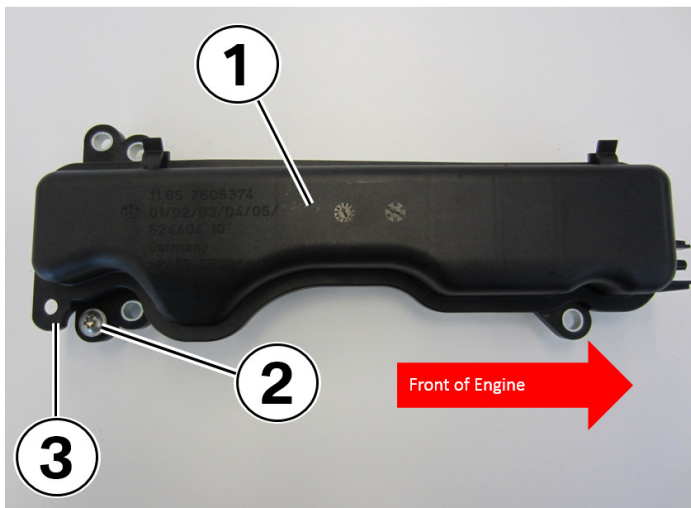
It is possible that a black plastic vacuum reservoir (1) is installed. This illustration provides an overview of the entire component and specific points of the component.

Reservoir (1)

Reservoir mounting screw (2)

Plastic vacuum reservoir tab (3)

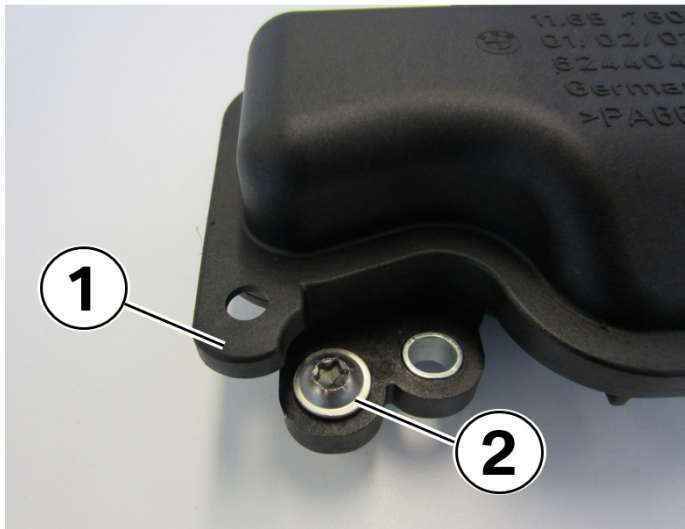
Plastic vacuum reservoir tab (1)

Mounting screw (2)

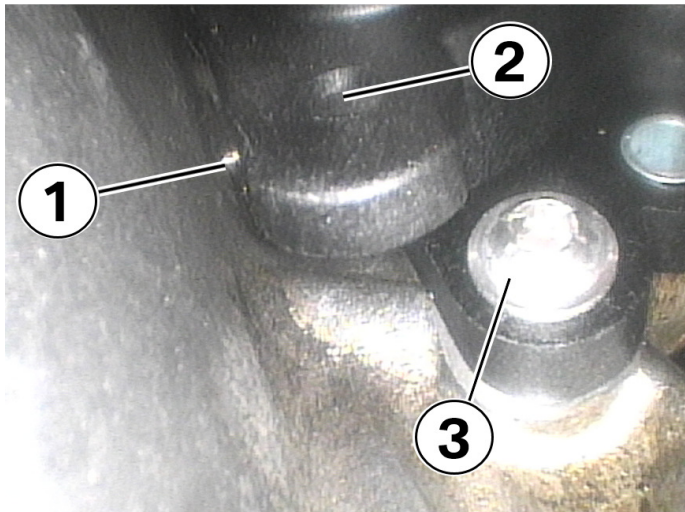
It may be more difficult to position the bore scope but it will only take a few minutes more to make the diagnosis.

Engine valley drain hole (1)

Plastic vacuum reservoir tab (2)

Reservoir mounting screw (3)

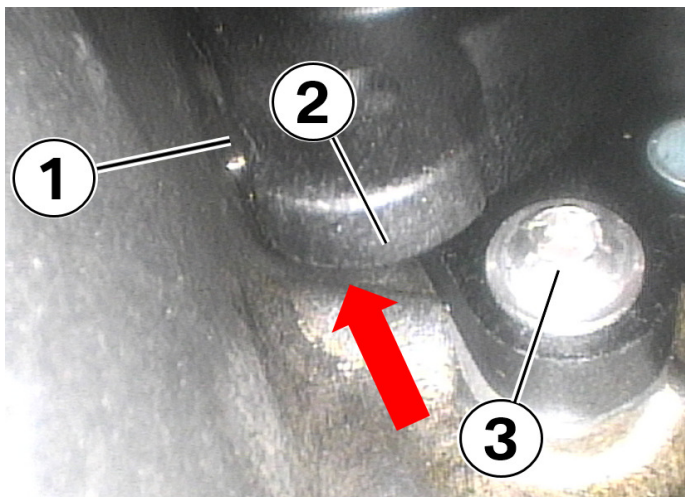
Continue to push bore scope down ward towards the plastic vacuum reservoir tab (2).

The bore scope needs to be moved towards the direction of the red arrow and under the tab (2) to have the best viewing angle of the engine valley drain hole (1).

Engine valley drain hole (1)

Plastic vacuum reservoir tab (2)

Reservoir mounting screw (3)

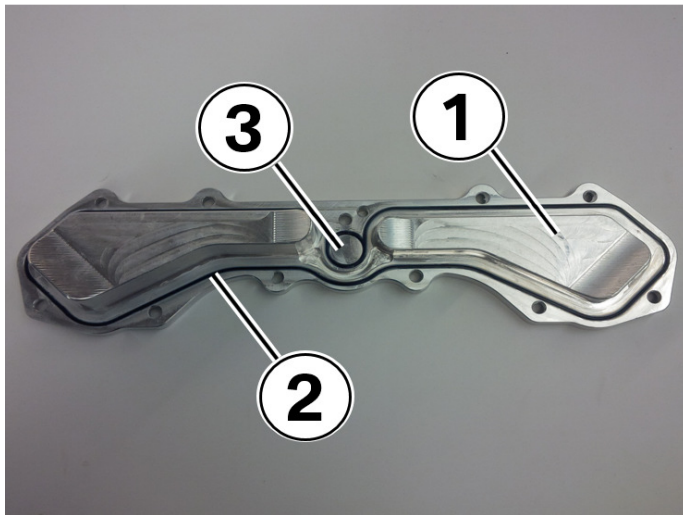
P/N 11 14 2 246 298 Updated End Cover, Rear Kit overview.

Billet aluminum housing (1)

Integrated Viton seal (2)

Additional sealed surfaced (3) to encapsulate the leaking engine oil galley plug.

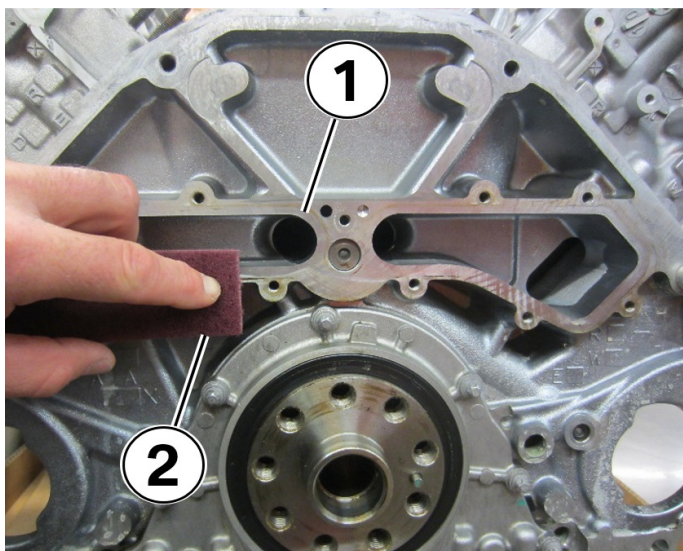
13. Clean the engine crankcase sealing surface (1) using the Scotch Brite cleaning pad (2) included with the new cover kit P/N 11 14 2 246 298.

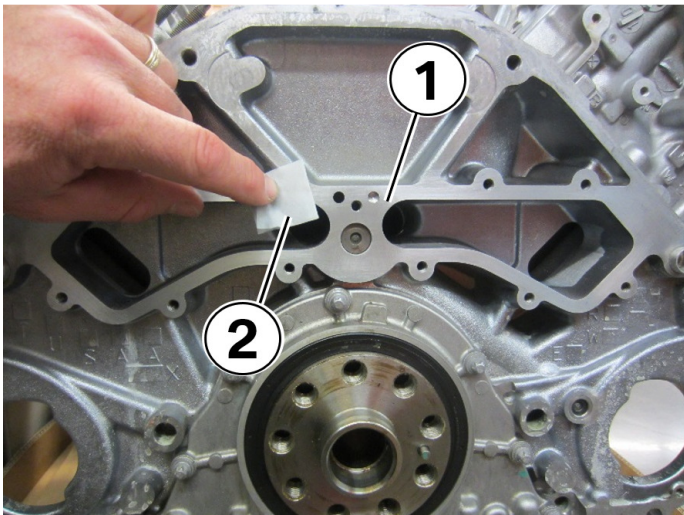
14. Remove all residual oils from the sealing surface (1) using the alcohol preparation pad (2) included with the new cover kit.

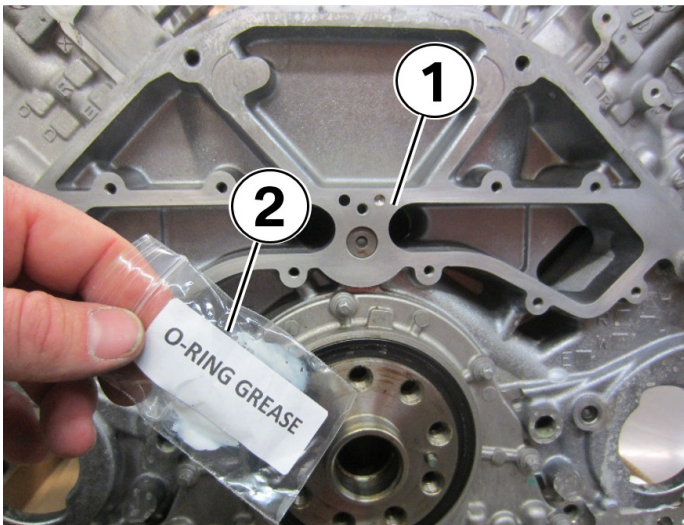
15. Lubricate the sealing surface (1) with the O-ring grease (2) supplied in the new cover kit.

Apply a thin film of grease over the entire sealing area.

The new cover already has O-ring grease applied to the sealing area. Do not remove the grease from the cover.

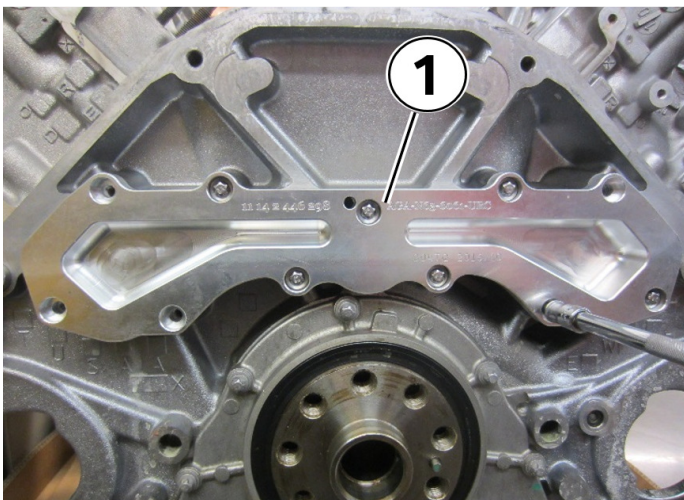
16. Install the new cover (1).

Refer to Repair Instruction 11 14 250 Removing and installing/sealing rear engine cover for the proper torque and assembly procedures.

Reuse the original M6 bolts and torque them to **10 Nm**.

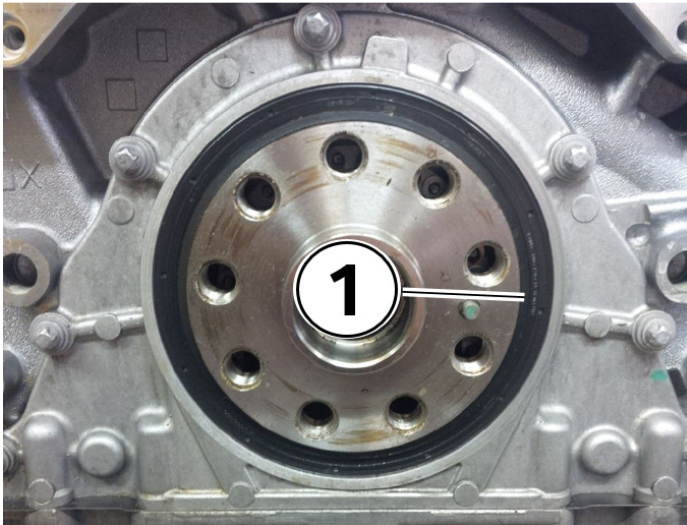
17. Replace the crankshaft rear seal and seal housing (1).

Refer to Repair Instruction 11 41 151 Replacing crankshaft radial seal on transmission side.

Always enter the vin number into ETK to receive the proper part number. **UPDATE!**
