**Procedure to check and/or repair the DME wiring harness connector A368\*1B.**

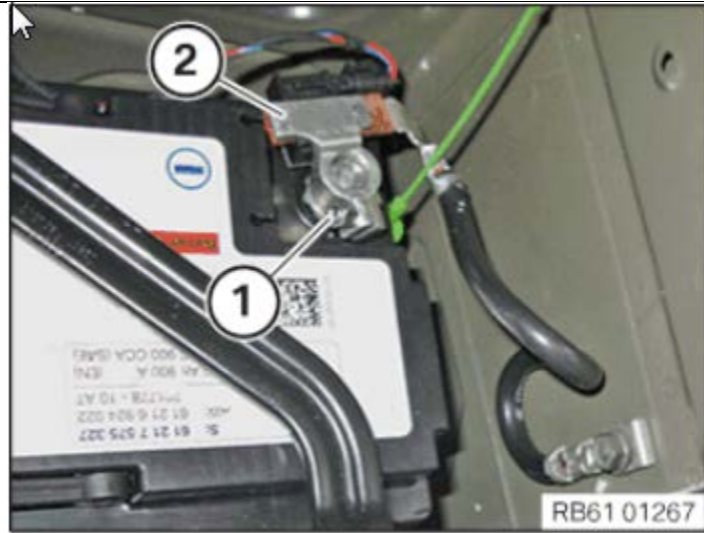
1a. Slacken nut (1) and detach battery earth lead from battery.

Note: Do not pry off using a tool.

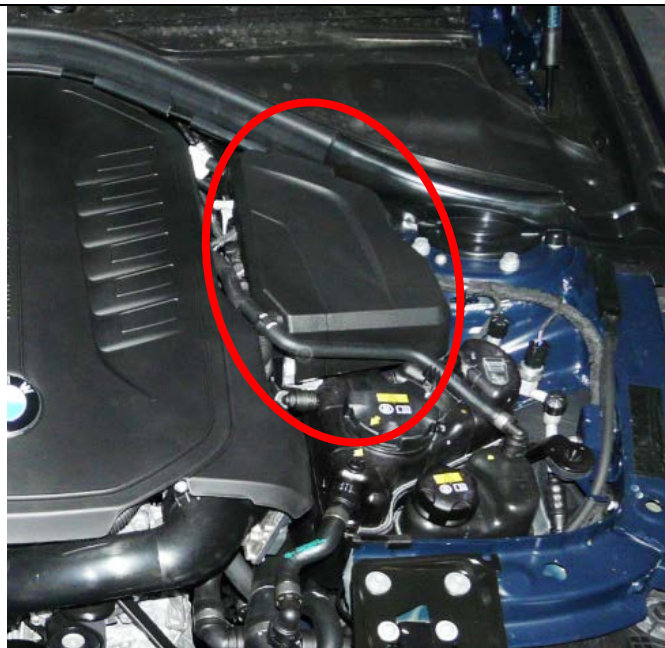
1b. Remove the cover of the DME control unit (circled, shown on B58 engine).

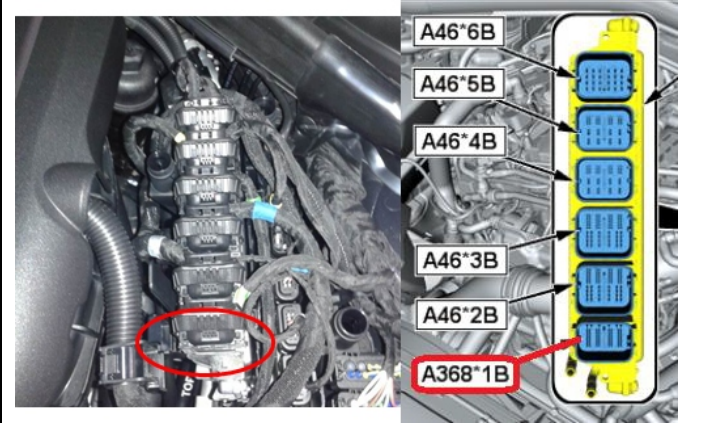
<p>1c. Locate connector A368*1B and remove it from the DME.</p>

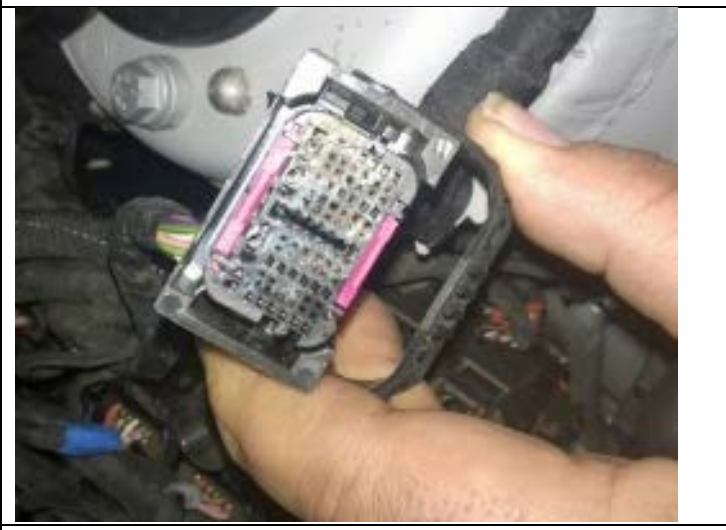
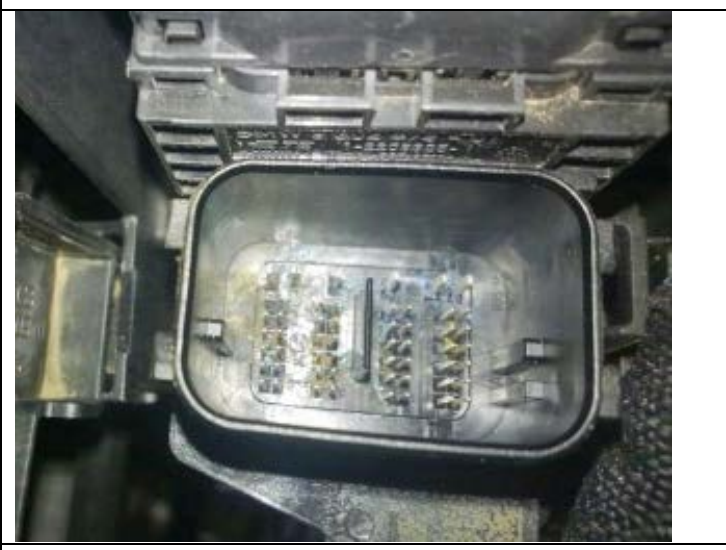
<p>1d. Check for water residue or corrosion in the connector and in the connector chamber of the DME control unit (photo below).</p>

<p>1e. Evaluation:</p> <p>If <u>no</u> water residue can be found on either component, proceed to <b>"2. Rework the connector"</b>.</p> <p>If <u>water residue or corrosion</u> is observed in the connector, proceed to <b>"3. Replace partial wiring harness and DME control unit"</b>.</p>
<p><b>2. Rework the connector:</b></p>

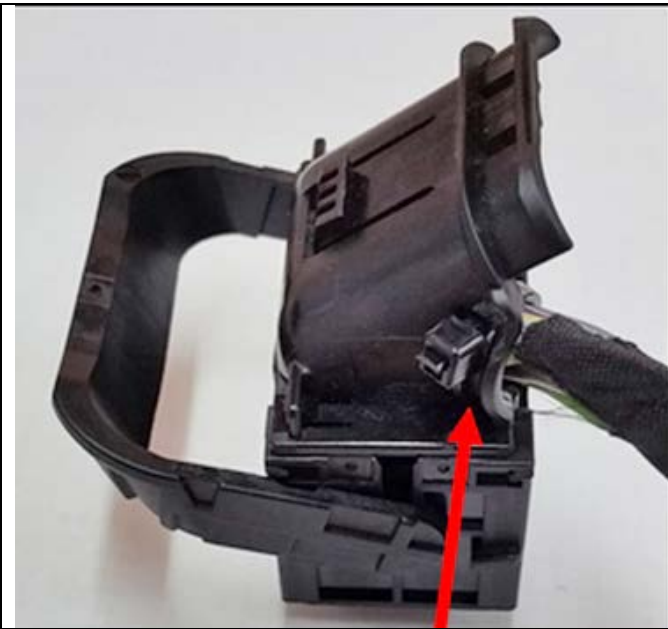
2a. Remove the cable strap (arrow) on connector A368\*1B.

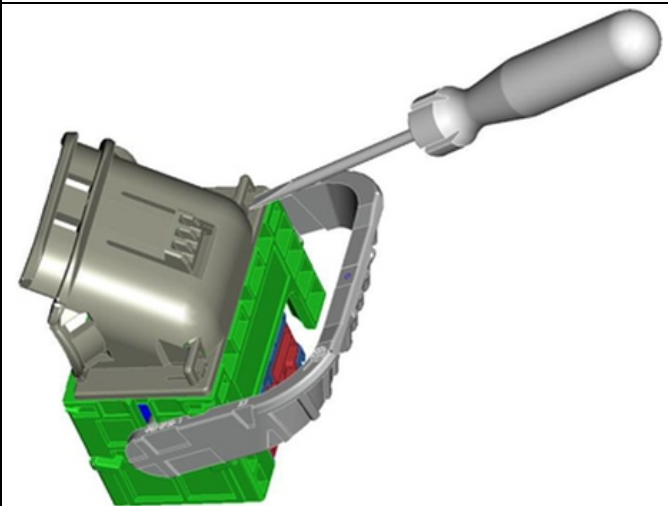
2b. Carefully remove the protective cap from the connector using a suitable tool.

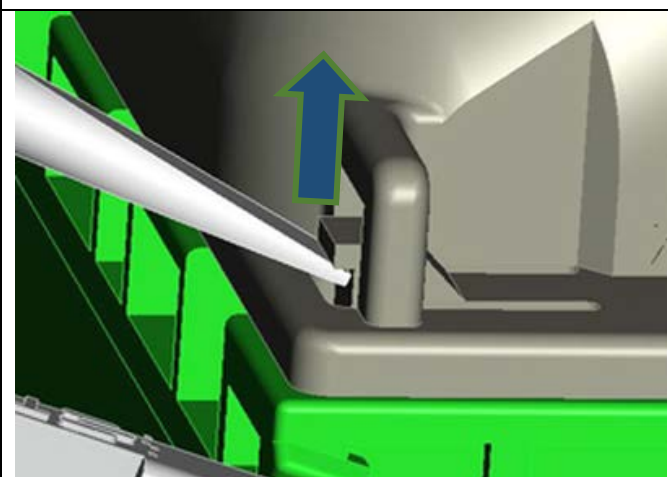
Lift the two locking tabs up

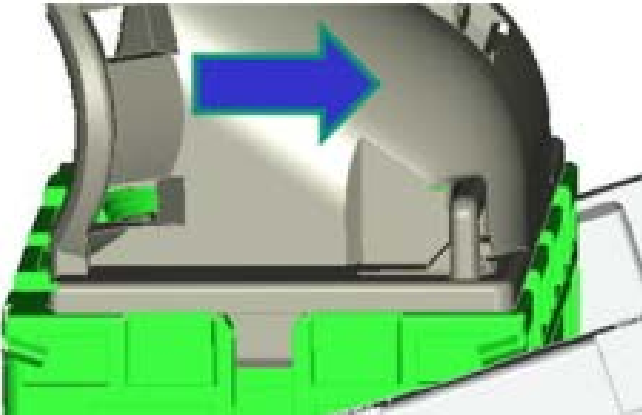
<p>Slide the protective cap in the direction of the lock lever</p>

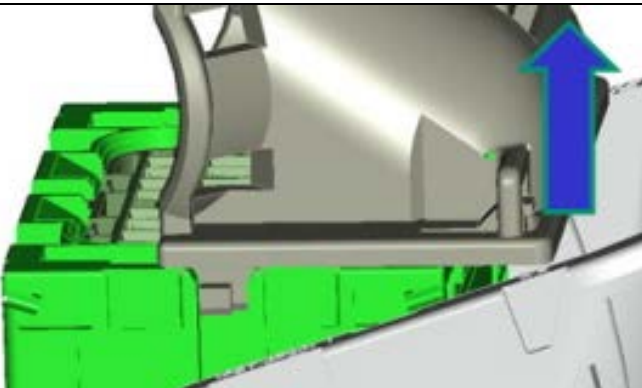
<p>Lift the protective cap off the connector</p>

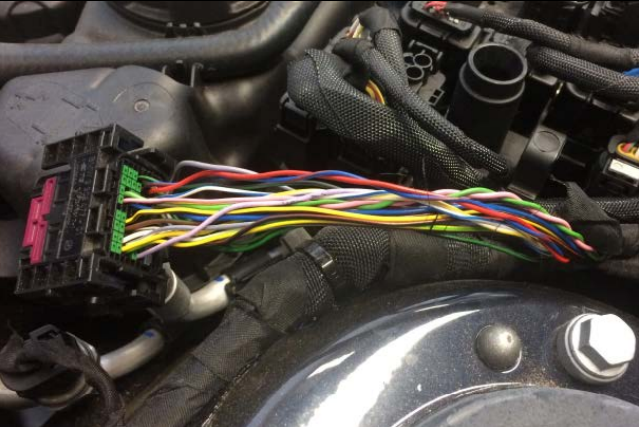
<p>2c. Remove approximately 4" of the insulating tape on the wiring harness from connector A368*1B</p>

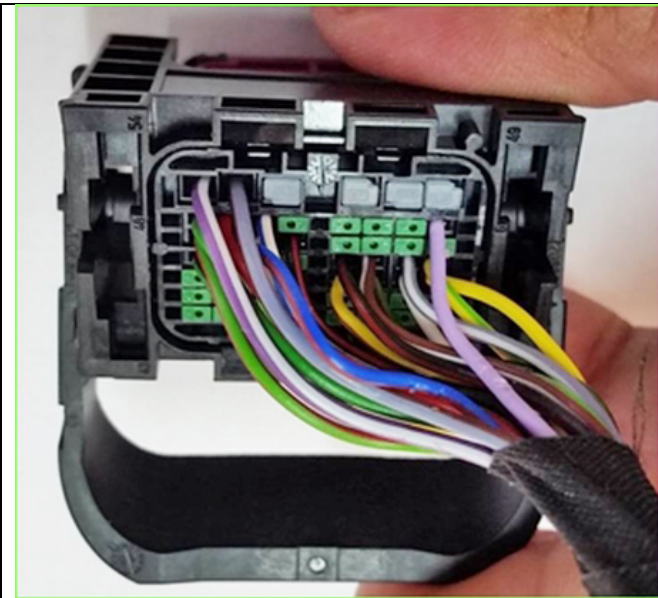
2d. All slots in the connector must be occupied with a wire or sealing plug.

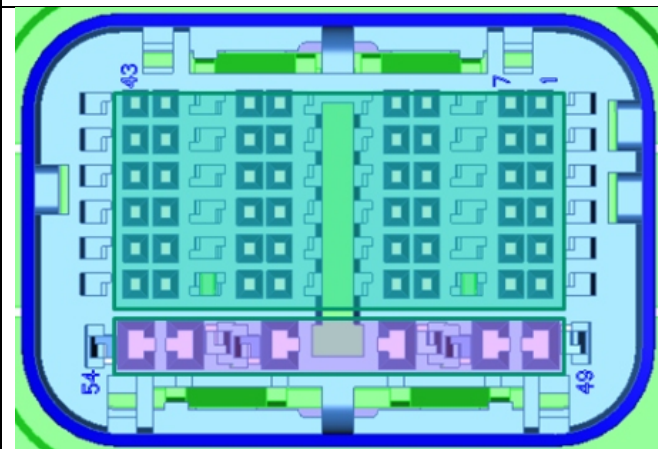
2e. Install suitable sealing plugs (Repair kit P/N 61 12 8 794 765) into all of the open chambers.

Fit green sealing plugs into the open chambers in positions 1 thru 48 on connector A368\*1B

Fit "natural colored" sealing plugs into the open chambers in positions 49 thru 54

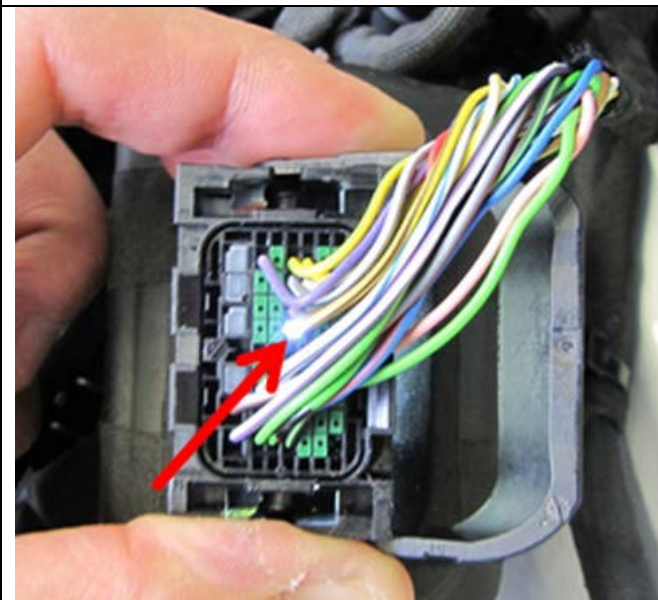
2f. Assembly verification:

Shine a flashlight from the front of the connector to locate any open chambers (arrow).

The best viewing perspective is vertically downwards from above the housing.

Install any remaining sealing plugs.

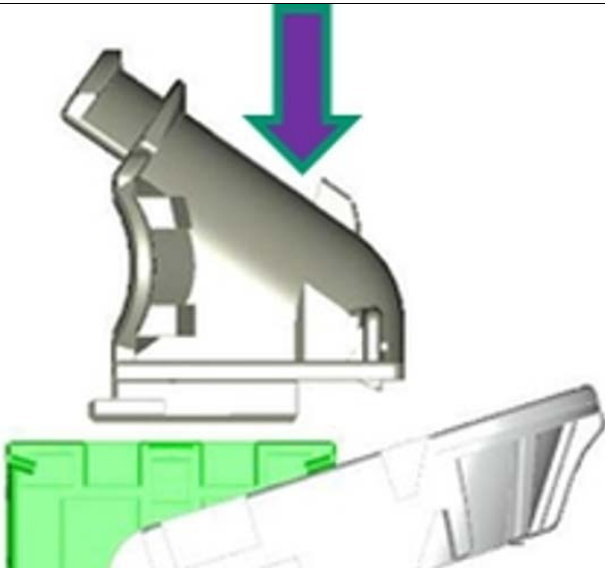
2g. Attach protective cap and replace cable strap

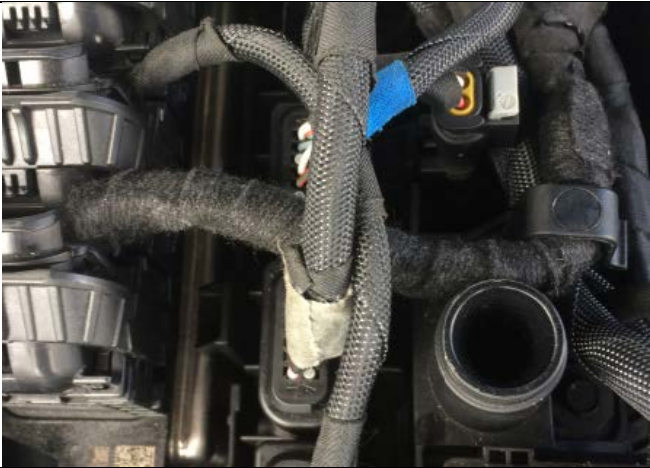
2h. Wrap the wiring harness with repair tape (P/N 61 13 6 920 760) up to the connector and reassemble.

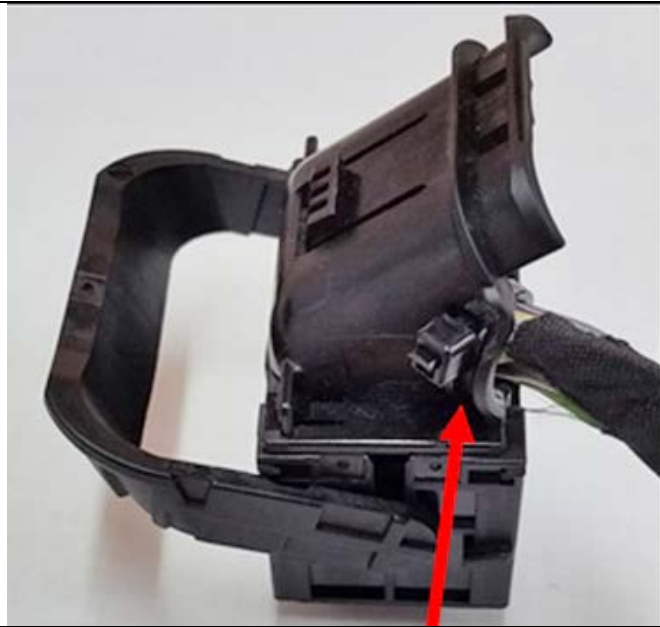
3b. Remove the cable strap (arrow) on both connector A368\*1B and the repair harness.

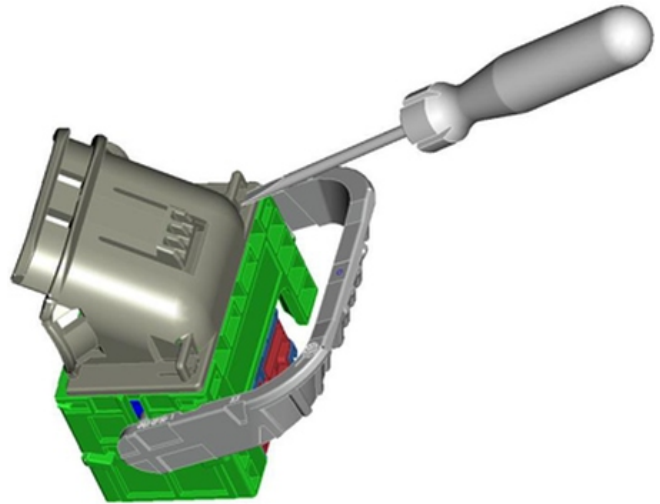
3c. Carefully remove the protective cap from the connector using a suitable tool on both connector A368\*1B and the repair harness.

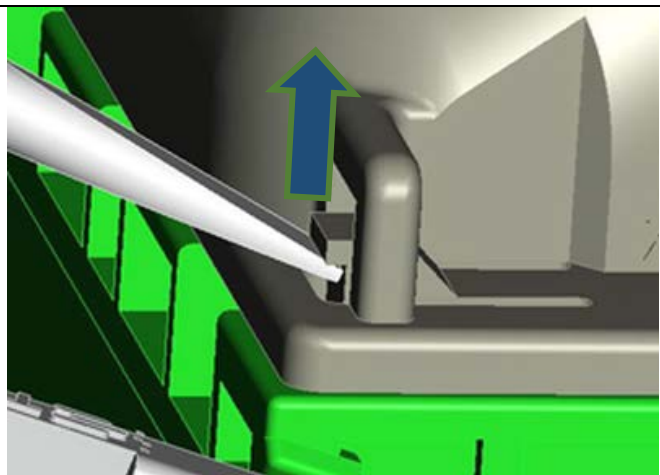
Lift the two locking tabs up

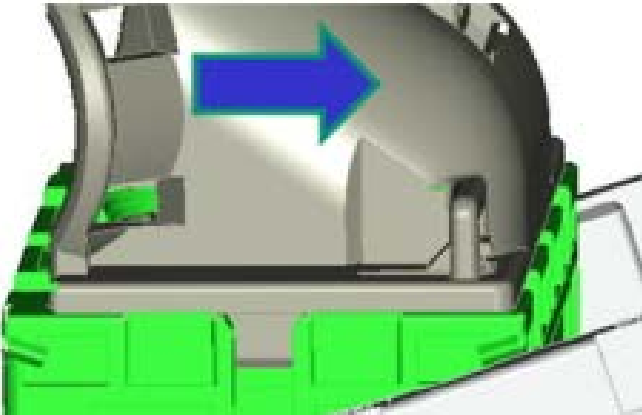
<p>Slide the protective cap in the direction of the lock lever</p>

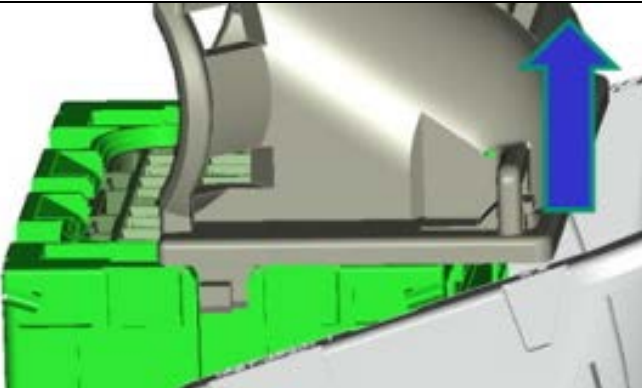
<p>Lift the protective cap off the connector</p>

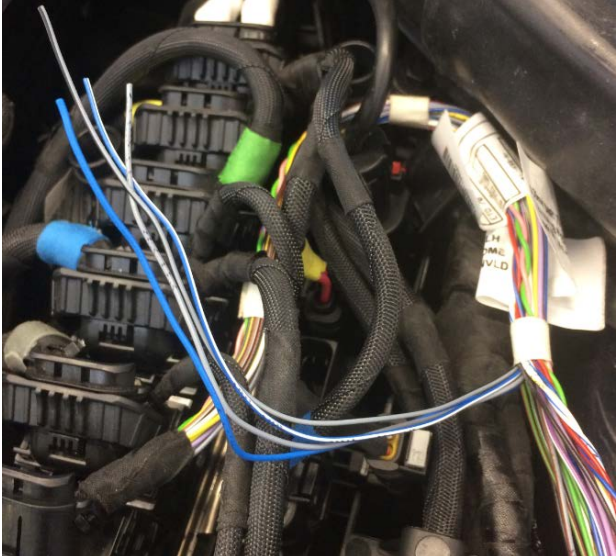
<p>3d. Route the repair harness in the installation position (Repair Kit 61 12 8 793 506).</p> <p>Compare the wire positions and colors of connector A368*1B and the repair harness.</p> <p>Separate and insulate the individual wires which are not required in the new wiring harness section with the “natural colored” shrink tubing.</p>

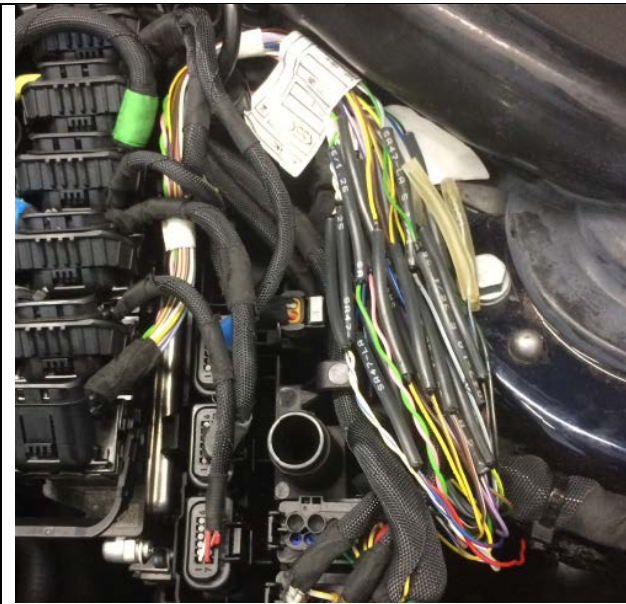
3e. Using the supplied butt connectors, splice in the replacement wiring harness, one wire at a time, using the black shrink tubing.

The splices should be staggered over a 4" area as shown.

Caution: Wire colors may be duplicated in the wire harness. Verify the correct circuits are connected by comparing pin locations.

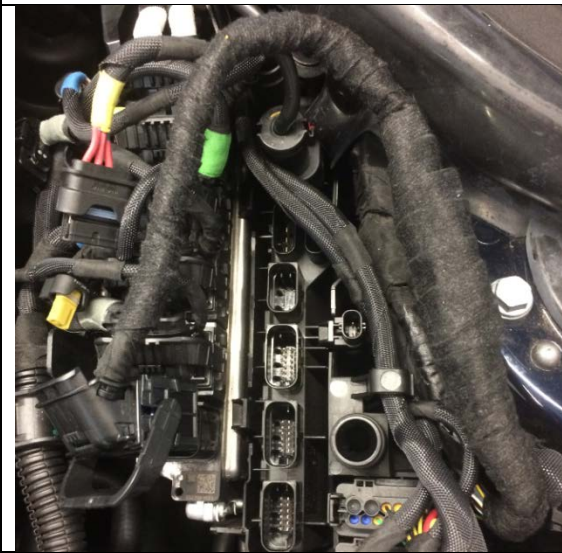
3f. Wrap the wiring harness with repair tape (P/N 61 13 6 920 760) up to the connector.

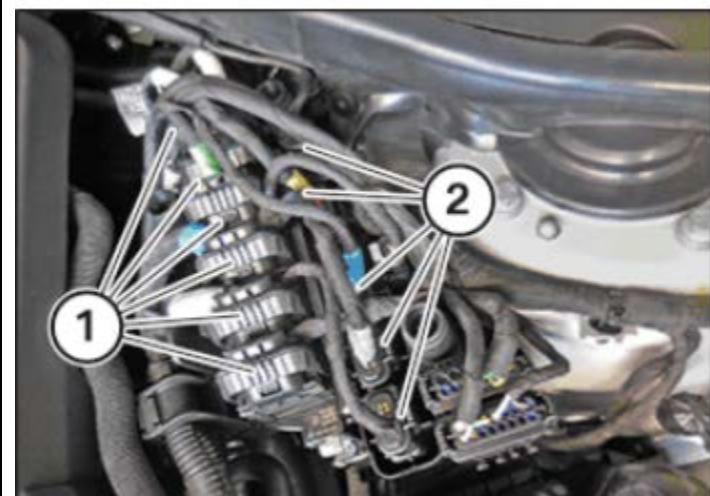
3g. Unlock all connectors (1) from front to back and unplug them from the DME control unit.

Unlock and pull all connectors (2) off the power distribution box (PDM).

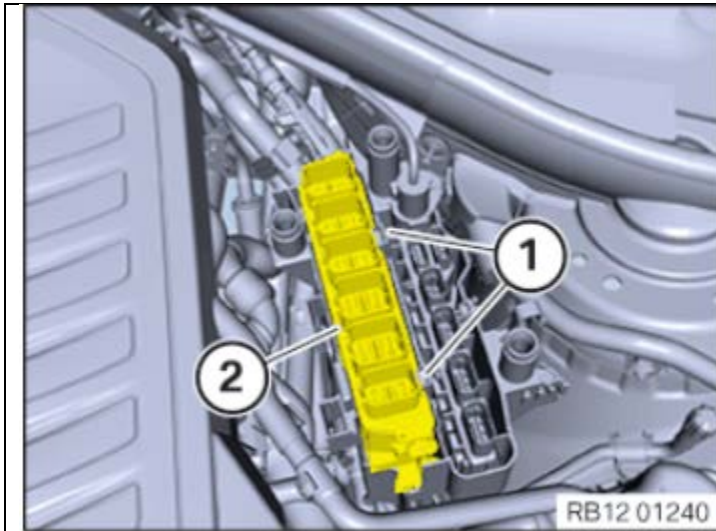
3h.Unlock clamps (1) and remove the DME control unit (2) towards the top.

Slide the replacement DME control unit (2) into the holder for the DME control unit and lock with the clamps (1).

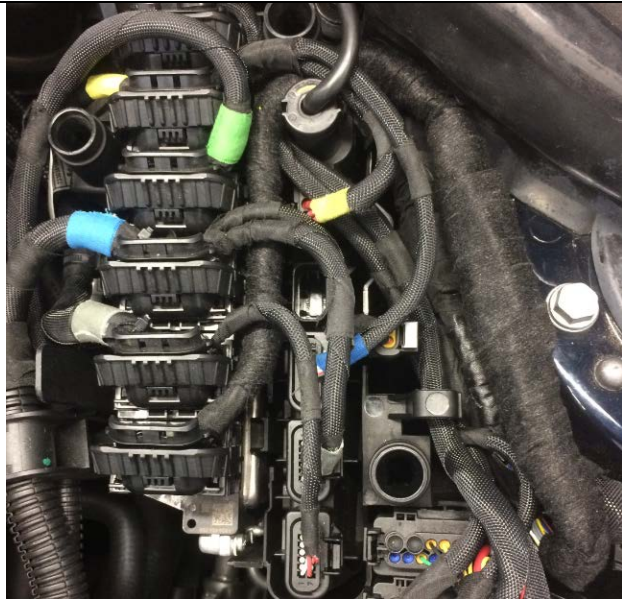
3i.Rout the repaired harness as shown and connect A368\*1B.

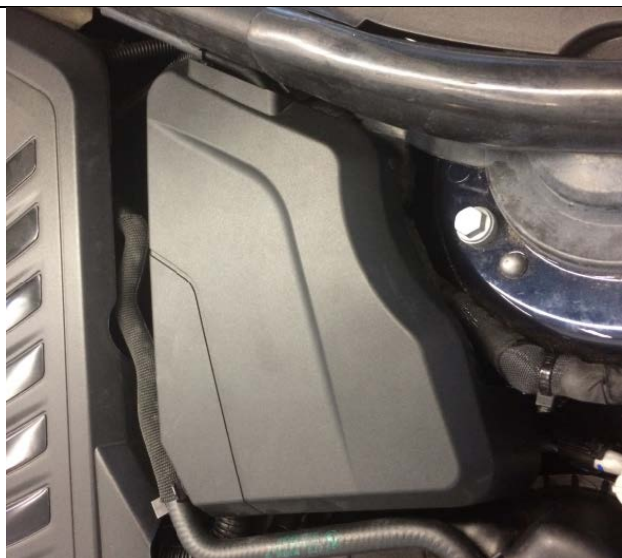
3j.Replace the cover of the DME control unit. Ensure the repaired harness is not pinched, rubbing on a sharp edge, and is fully covered by the DME control unit cover.

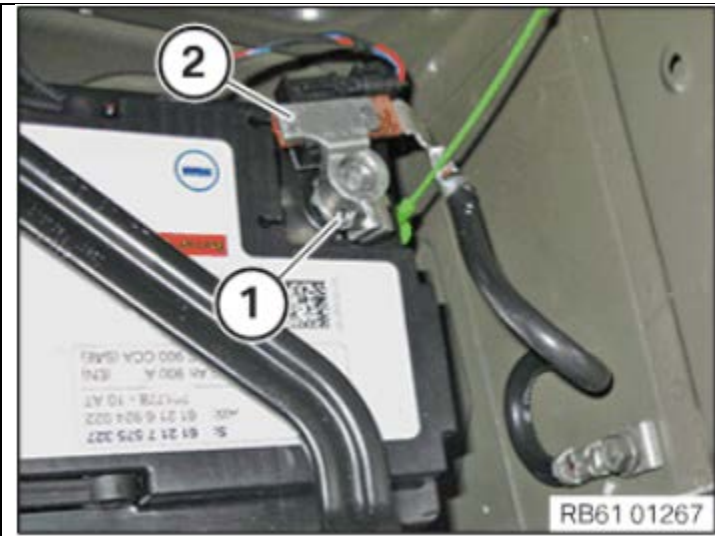
3k. Connect battery earth lead with intelligent battery sensor (IBS) (2) to negative battery terminal.

Tighten nut (1) to 5Nm.
