REPAIR INSTRUCTIONS FOR G12 SUNROOF NOISE

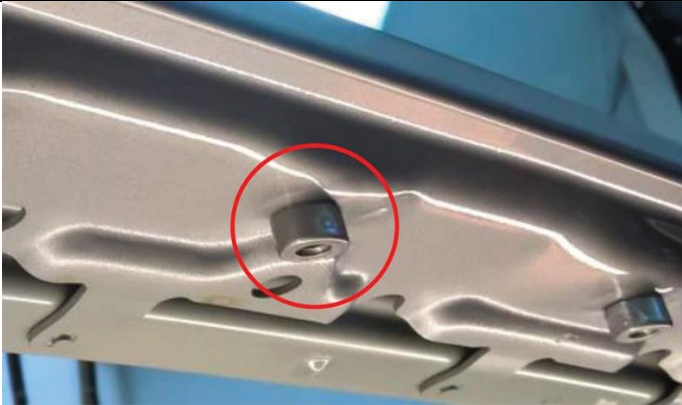
<p>1. Remove the rear sunroof glass panel following repair instructions REP 54 13 250 “Removing and installing/replacing rear glass slide/tilt sunroof panel”. The front glass slide/tilt sunroof will be removed at the same time.</p>

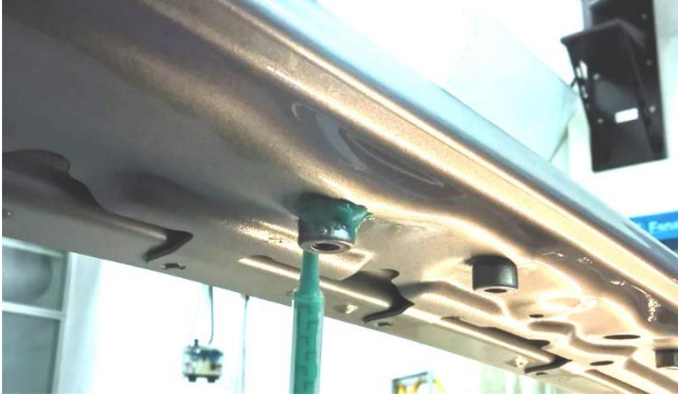
<p>2. With both glass panels removed from the vehicle, reinforce the threaded bushings by completing the following steps.</p> <p>A. Clean the surface area around each threaded bushing with R2 cleaner. Allow to air dry for 2 minutes.</p> <p>B. Clean the area around each threaded bushing with R1 cleaner. Allow to air dry for 2 minutes.</p>

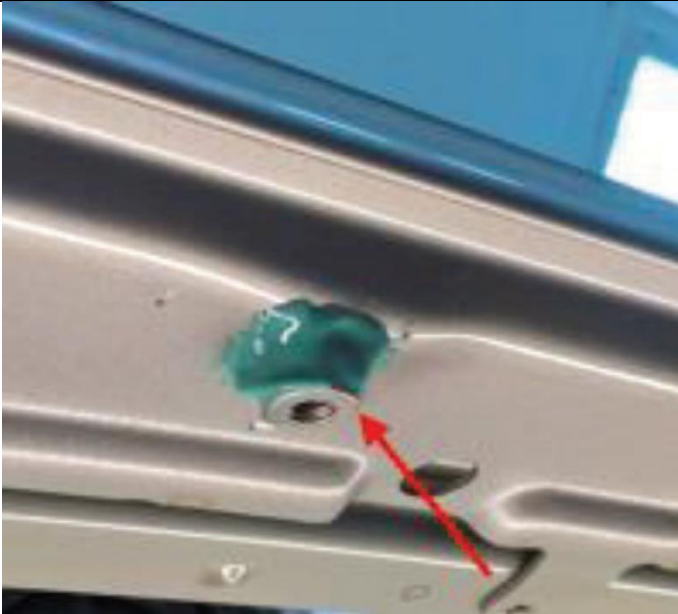
<p>C. Use cartridge gun 83 19 2 149 522 to apply K5a body adhesive around the side of each bushing as shown.</p> <p>

Note: Apply adhesive on all of the threaded bushings on the roof for the front and rear glass panels.</p>

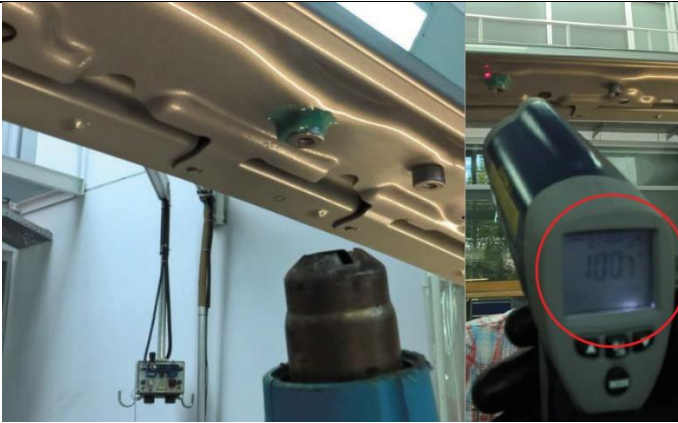
Note: Keep all adhesive off the flat surface of the bushing.</p>

<p>D. Heat the applied adhesive with a heat gun to an approximate temperature of 175 to 212 degree F (80-100° C). Check the temperature with an infra-red thermometer.</p> <p>E. Apply another layer of adhesive to the side of the bushing repeating Steps 2C and 2D, above.</p> <p>F. Allow the adhesive to cure for at least 12 hours.</p>

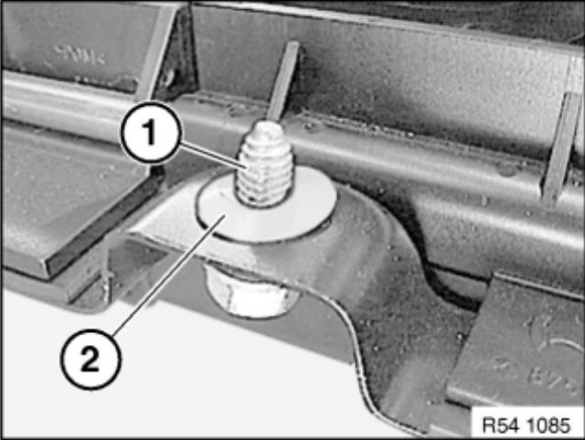
<p>4. Reinstall the front glass unit into the vehicle, using new screws (1). Be sure to install plastic washers (2) between the sunroof cassette and the threaded bushing.</p>

<p>5. Coat the front screw threads with medium-tight thread locking adhesive (Loctite 243) (BMW part # 83 19 2 210 339).</p> <p>

Note: Tighten screws, with a torque wrench, to exactly 10 Nm.</p> <p>Over-tightening or under-tightening will lead to a loose connection and a repeat visit.</p>
	<p>6. Before completely assembling the vehicle, test drive and verify the roof noise is no longer present.</p> <p>7. If the noise is no longer present after the repair, completely reassemble the vehicle.</p>
