- E9x (3 Series) and E82/E88 (1 Series) from 09/08 with option 609
 - Road Map 2009-1 for the Car Information Computer (CIC) navigation system
- NAV road map set shipped to all BMW Centers through the Automatic Tool Shipment Program

- E83 (X3), E60 (5 Series) up to 11/05
 - Recall for OC3 mat (update)

- E70 (X5), E71 (X6) produced up to 8/08 and equipped with Comfort Seats
 - Thigh support cover loose

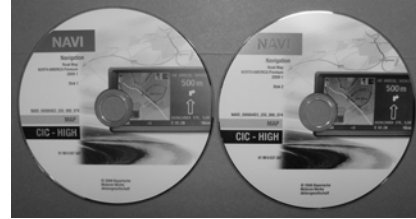
- CIC NAV road map set contains two DVD's

- Current CIC replacement parts come with a preloaded NAV road map 2009-1
 - No need to update the road map
- Store the NAV road map set 2009-1
- Aftersales & Marketing Info PB 650109
- SI B65 05 09 follows
