## EME GROUND CONNECTION MONITORING FAULTS

### PROCEDURE

For **G01/ G05/ G12/ G20/ G30**:

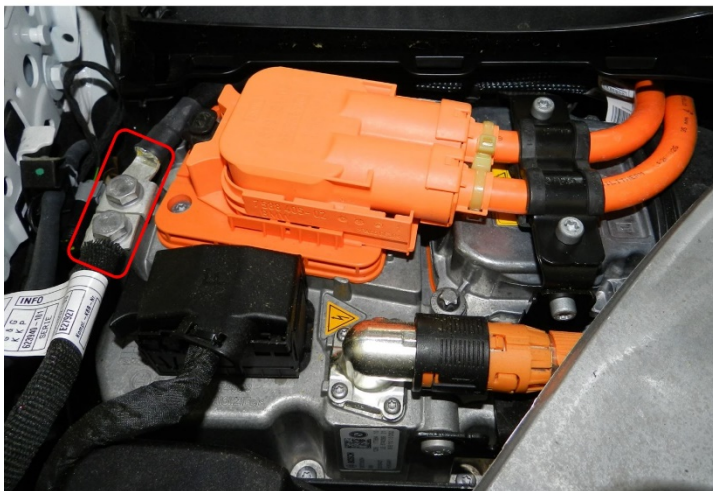
GRUSB1219-09

1. Remove both grounding cables at the EME. (G30 shown)

- Program the vehicle with ISTA to I level 20-11-500 (available since November 2020) or a more recent version.
- Then remove both grounding cables at the EME (electrical machine electronics), and follow cleaning procedure illustrated below.

**Note: Replacing the EME (electrical machine electronics) is not required and will not correct vehicle concern**
